**ENVIRONMENTAL TEST
SONY DIR-1000, ID-1 DIGITAL TAPE RECORDER
(VIBRATION, TEMPERATURE AND HUMIDITY)**

John Morgan and Paul Beer
Mission and Avionics Technology Department (Code 5053)
NAVAL AIR WARFARE CENTER — AIRCRAFT DIVISION
Warminster, PA 18974-5000

13 MARCH 1992

FINAL REPORT
Period Covering 20 January 1992 to 24 January 1992

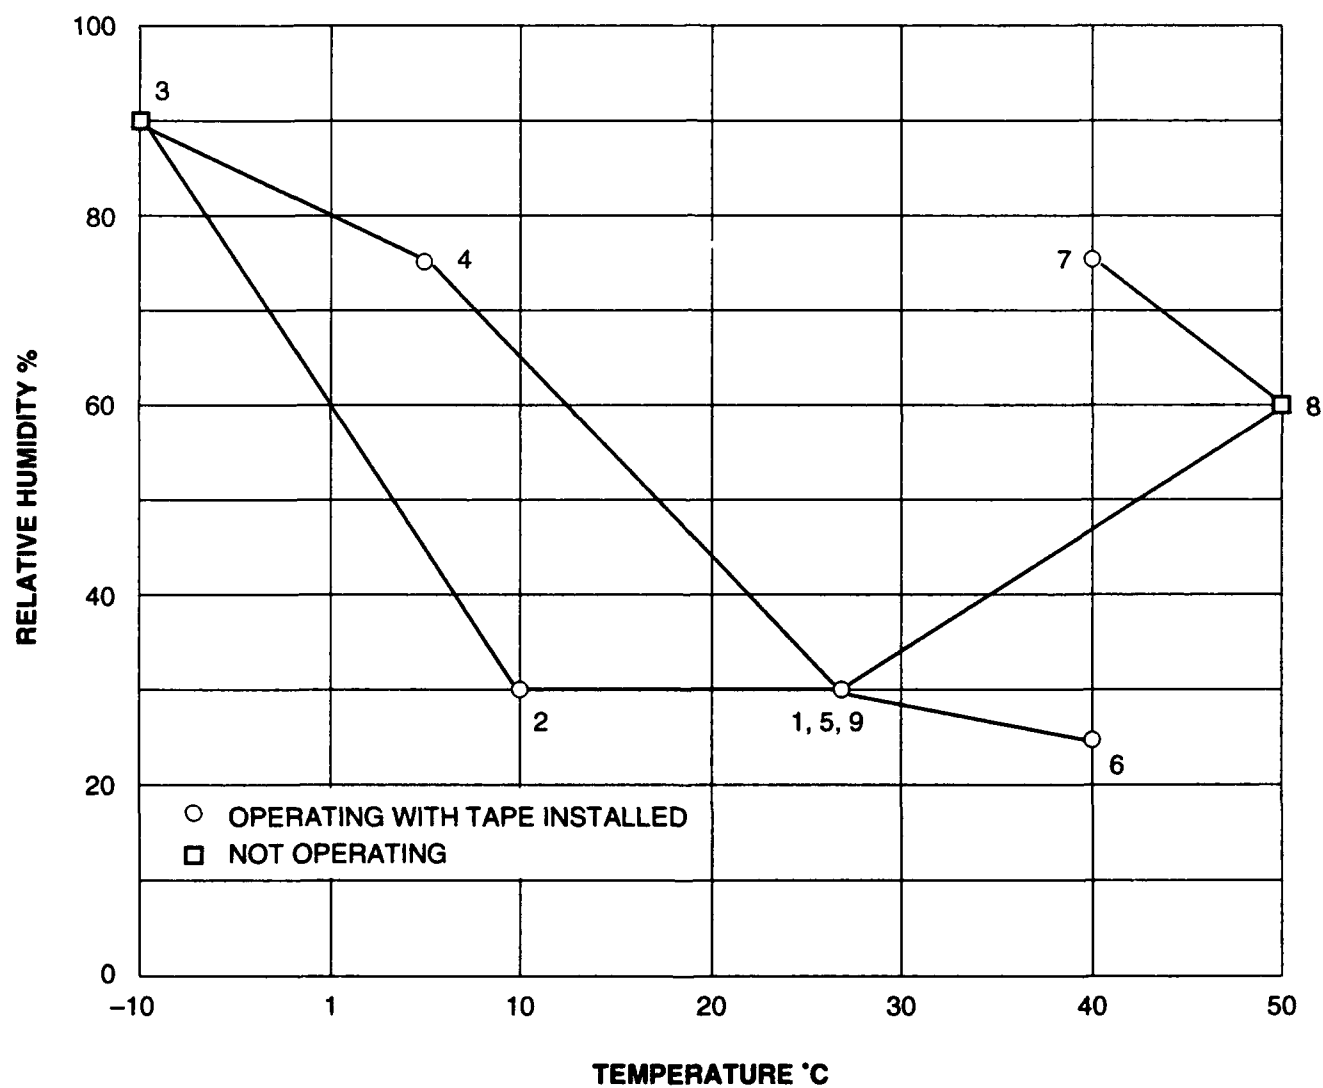
Figure A-5.

Figure A-5 shows the T/H "path". Note the nine "test points". Also refer to Table II. The word "TRANSIT" as it appears in the Temp and Rel Hum columns of Table II
